## A guide to buying a VW Mk1 Golf Cabriolet

**Issue 6 - 08 June 2010**

This guide concentrates on the additional points to be aware of when buying a Mk1 Cabriolet. It may also be useful when preparing / checking your car for sale.

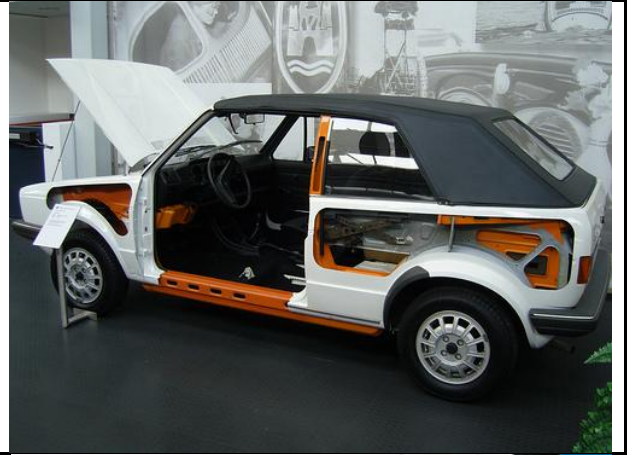
This cutaway illustration shows the extra body strengthening built in by Karmann coloured in red.

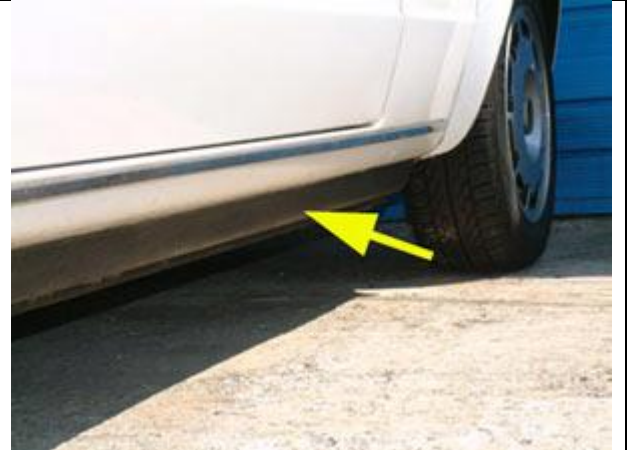
### Sills

These beams are not found on the Hatchback version.

On Clipper, Sportline and Rivage models these are covered by the side skirts, so any rot here will be hidden.

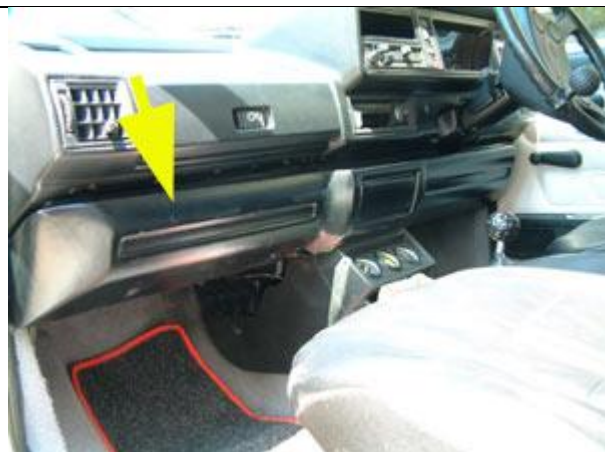
### Knee bar

This stretches full width across the car, under the dash behind the cover (black here, but some later models were colour coded).  
There should be no holes drilled through this trim/panel.

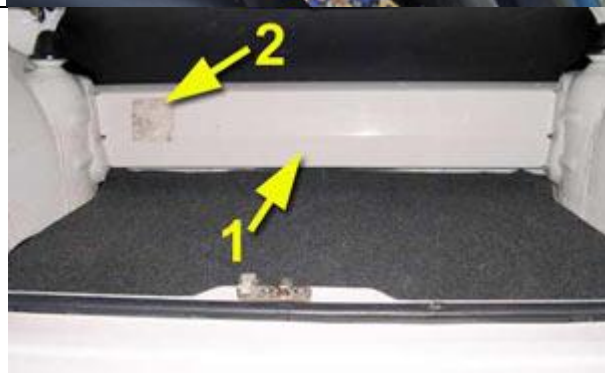
### In the boot:

1. Beam between rear turrets – check for any signs of damage / rust
  2. Vehicle data sticker
- (see Luggage Compartment (Boot) - opening

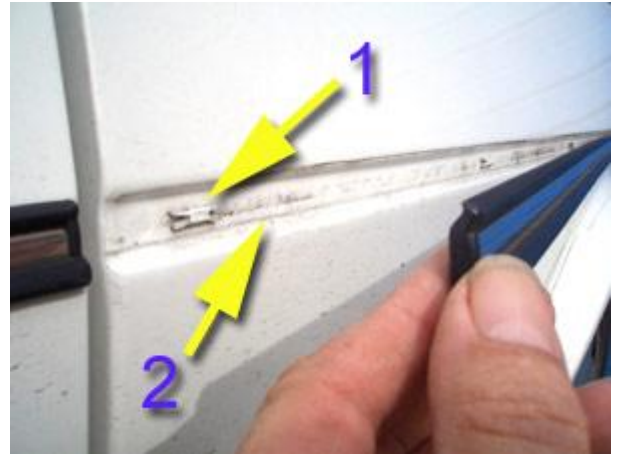
Check the 6 side trims (3 each side)...

....they should all match (there are various styles – all black, chrome inserts, smooth, grained....)

....they should all be held tightly by the clips (1) – these are available cheaply, and should be replaced regularly when the trims are removed for cleaning.

A lot of dirt – and rust – can be hidden here...and on the rear  $\frac{3}{4}$  panel there is a welded seam, which should be checked closely.

Look at these clips carefully – if the car has been re-sprayed chances are that these have been sprayed as well !!

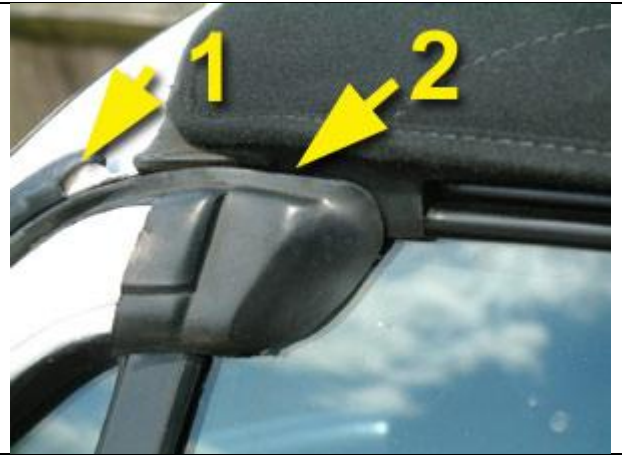
1. This plastic trim needs replacing.
2. The seal should make contact with the header and frame seals.

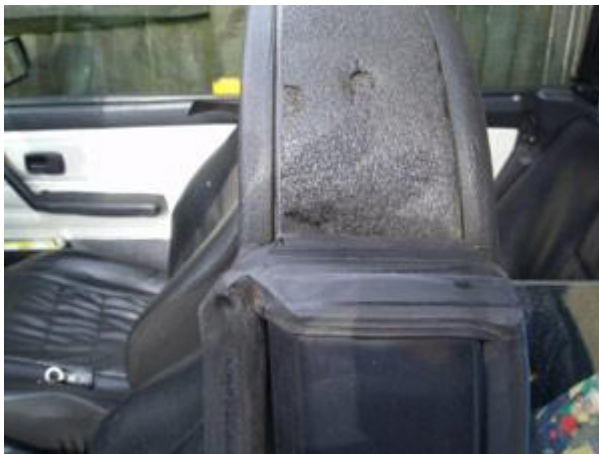
The door seals are different from the tin top – a one-piece going up, over and down the 'B' pillar. This one is on it's way out.....

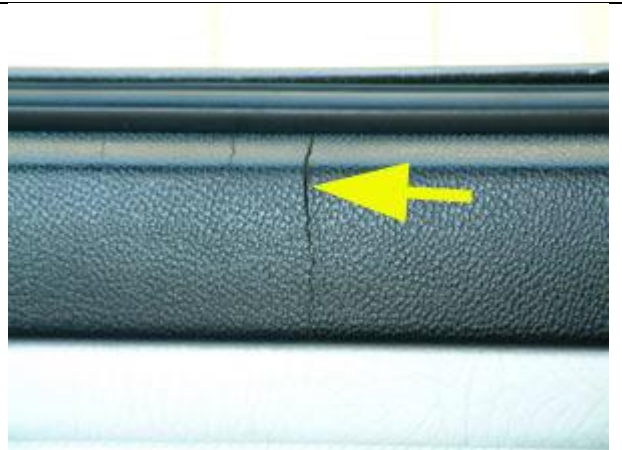
The upper door capping trims are prone to cracking.

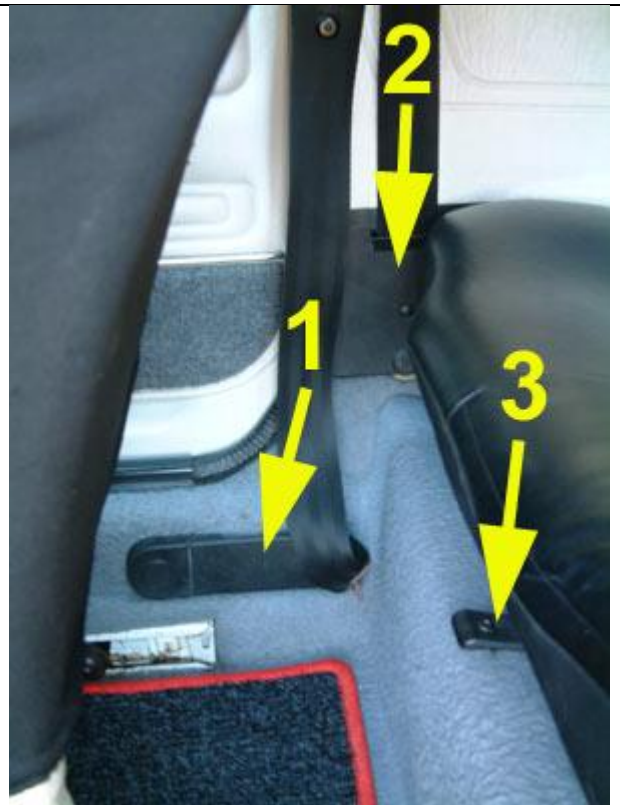
### Front seat belts

1. A spring loaded cover holds the front seat belt out of the way of passengers getting in and out of the back.
2. The front seat belt reel is protected by a cover which should be held firmly in place, and not restrict the movement of the belt through the slot.
3. There are two brackets with covers that hold the rear seat base in position.

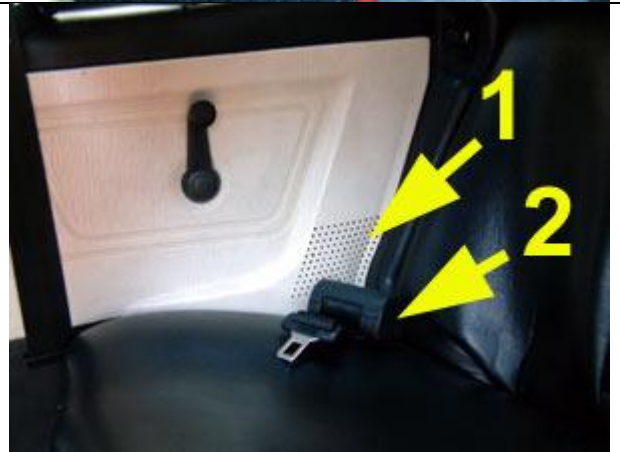
### Rear side panel cards

1. A small circular speaker lurks behind this panel.
2. Rear lap belt.

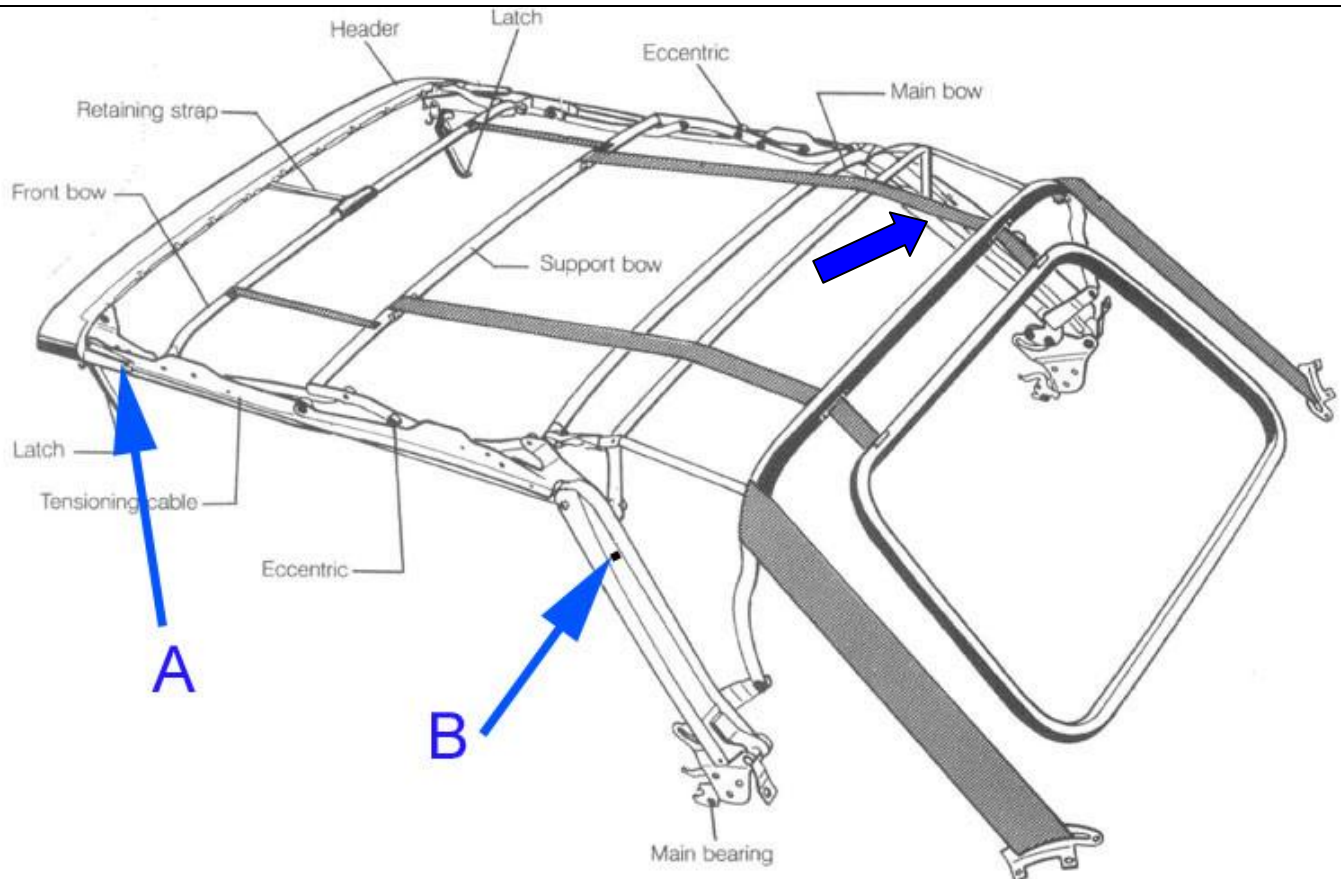
Fig. 8-1. Convertible top mounting frame. Top adjustment points are at front latches and left and right eccentrics.

The illustration above shows the manual roof frame. Only one of the gas struts is shown (plain arrow just below the 'Main bow' at top right).

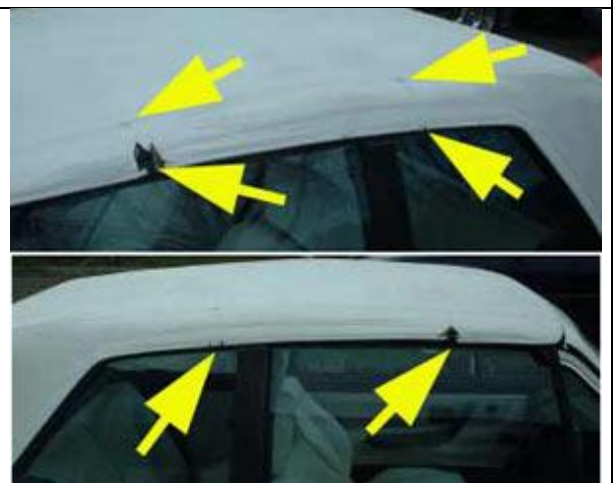
Check for rips / tears / cracks as shown here – this roof is on it's way out, and it WILL leak very soon, if not now. Check for water marks on the seats – remove seat covers if fitted !!!

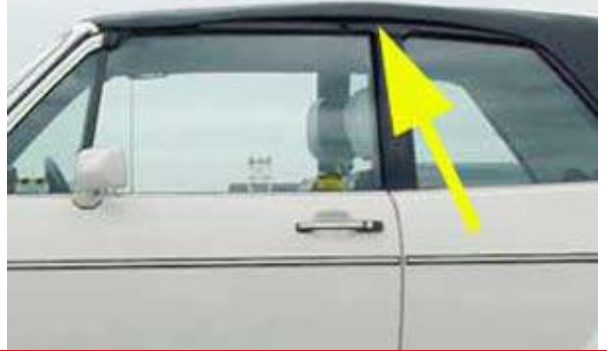
### Side tension cables

These are broken / missing.

These cables can still be obtained, and are relatively easy to replace in situ – but a bargaining point !!.

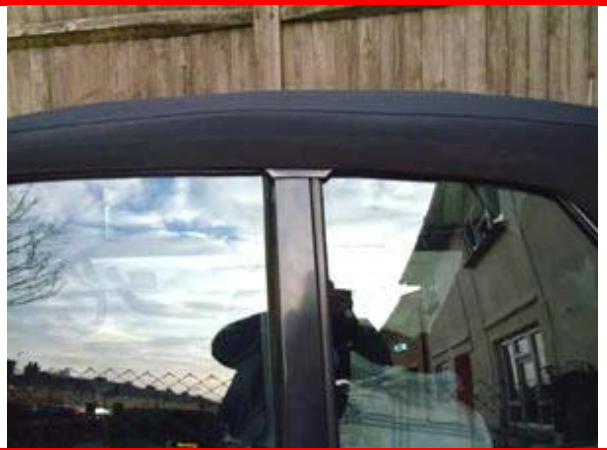
This is how the sides of the roof should look, they follow the frame / window line.

The top of the roof should be fairly smooth, with no noticeable hard bumps, lumps or sags (indicating that the inner horsehair insulation/padding layer and / or straps (see roof illustration page 10) are past their best).

The tension cable is in the seamed edge of the material. A spring, located at the rear frame upright (early models) or at the roof header (later models), holds the cable under tension (refer to the illustration on the previous page).

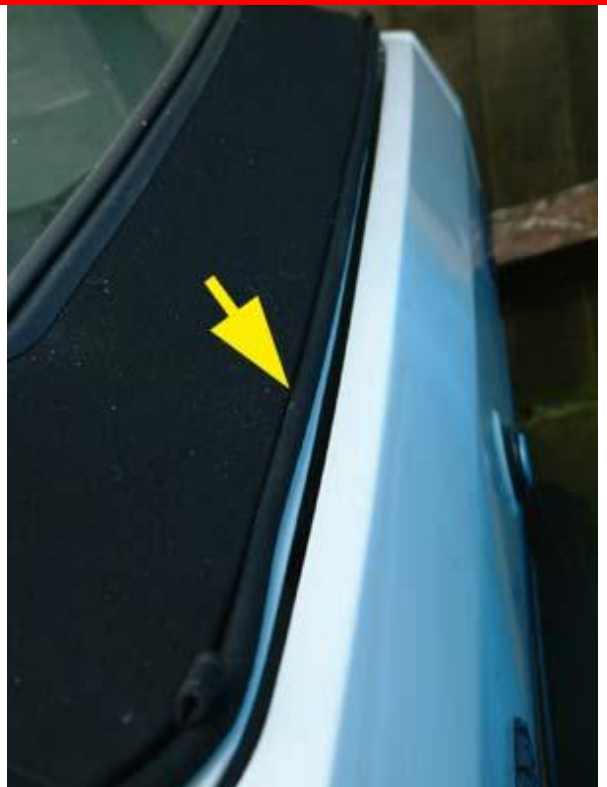
This cable sits outside the outer skin but up inside the rear lip, and should not be visible. It also holds the loops for the 'G' shaped hooks of the hood cover (see page 16).

The pic below shows what may be lurking on this lip hidden by the outer skin....mine when I bought it !!

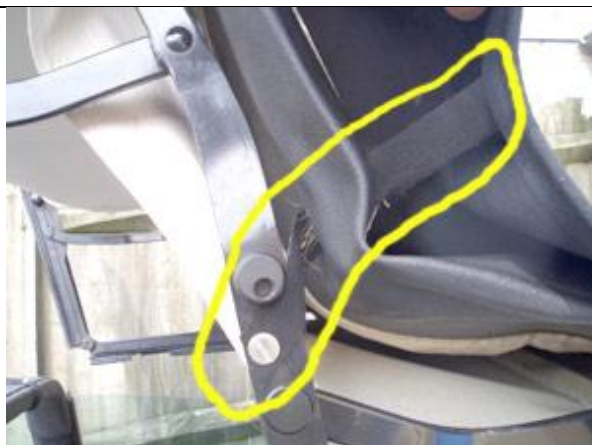
**Insulation layer and outer skin retaining strap**

The strap (outlined in yellow) is important – if this is missing / broken the roof will not fold back correctly – as in the next pic.

This layer also provides padding between the frame and outer skin to provide a smooth roofline (if you can see the outline of the frame support and main bows clearly when the roof is closed then this layer is missing / worn).

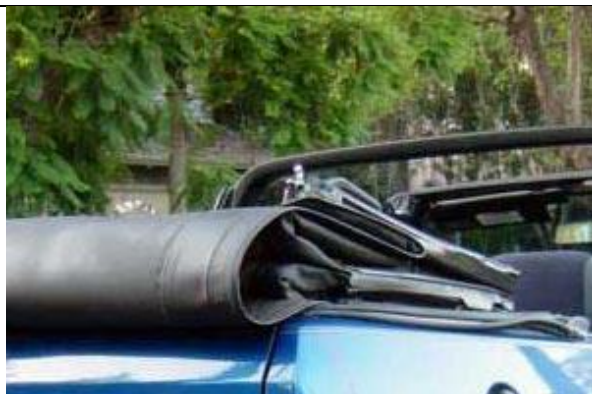
When the roof is folded back it **MUST NOT** look like this! The hood bag / cover will not fit over this, and it will flap when driving at speed.

This is caused by broken straps between the outer skin, insulation layer and the frame (see pic above).

See item 2 of the last pic on page 15 for the correct fold.

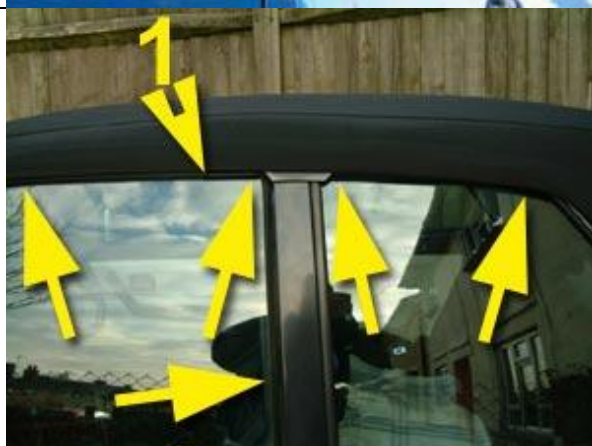
**Windows and window seals**

Check how the windows sit against the upper (frame) seals and the 'B' pillar weather strips. There should be no gaps and the glass should lightly compress the seal rubber. Possible causes of incorrect seating are badly hung doors, incorrect window adjustment or twisted/damaged roof frame.

Check also that where the roof seals meet (at the frame joint – 1) they are in line and have no gap (there should be a small gasket in the joint).

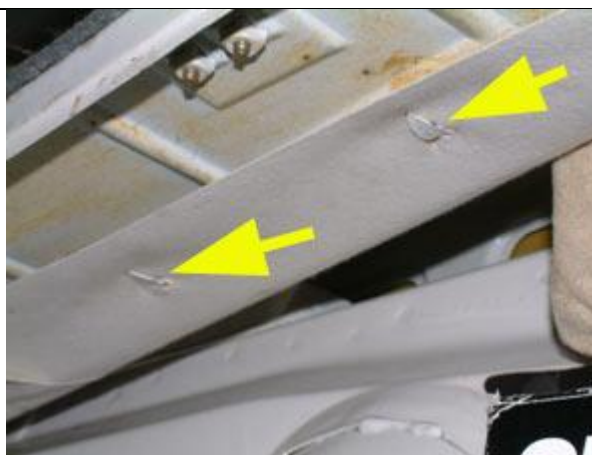
The roof lining is held in position by lots of these (sharp) tabs under both parcel shelf support panels. This headliner has been replaced; the glue from the previous (original) is still visible.

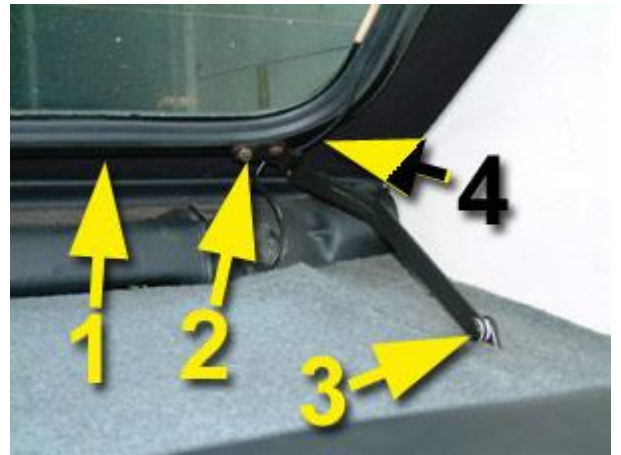
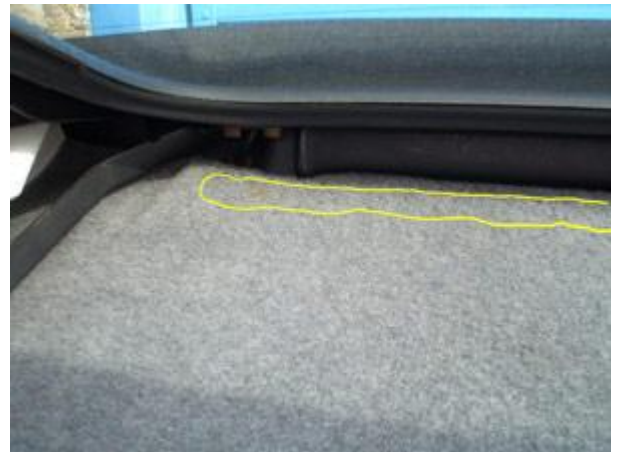
Even if the roof has been renewed recently **CHECK THE REAR WINDOW FRAME!** *Some trimmers do not replace the frame, and also re-use the old seal.*

1. If necessary remove the parcel shelf, get in the boot, and check the frame for any signs of rust, particularly here. Peel back the seal.
2. Check that both bolts are present on both sides.
3. This hinge should be free but not loose.
4. Check the rear window heater cables (both sides) for damage.
5. Check the parcel shelf for rusty marks (outlined in lower pic)

If the roof is old this frame **will be very rusty, and it will leak.**

Replacing it **AFTER** a new roof skin has been fitted will be very difficult, probably requiring another new outer skin.

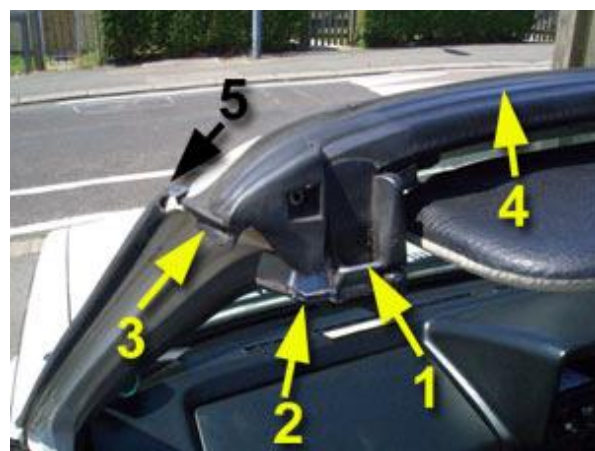
1. Recess for locating peg. These are over-engineered and should last forever.
2. Locating recess for 'J' hook (underneath), again over-engineered.
3. Weather seal – part of the header seal – should not be damaged. Water should not get past this unless the door is badly aligned.
4. Header seal, the ribs should stand slightly proud. An accumulation of dirt etc. here can lead to water getting in.
5. Side trim – this one needs replacing!

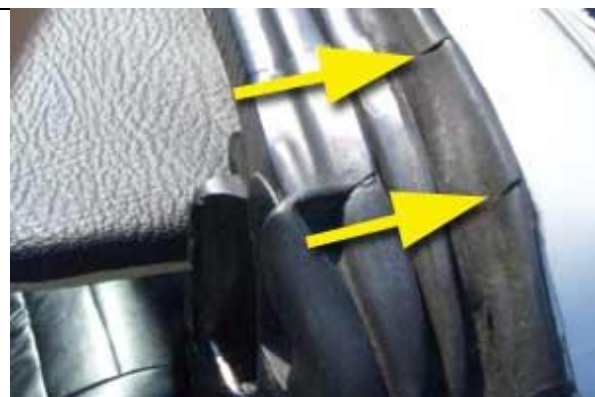
### Header seal

These splits, just in front of the sun visor, really need sorting – and a new header seal is about £60 !

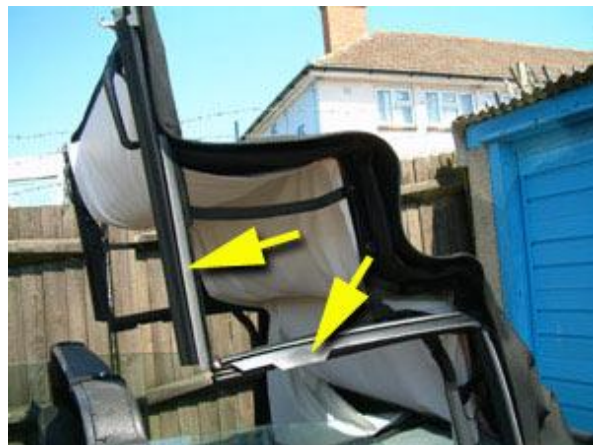
The roof should fold back smoothly with little effort. A perfect example needs only one hand to open or close it. Any jerkiness/stiffness will indicate seized/worn hinges, seized/loose/broken gas struts or a distorted frame. Check all hinge points for rust/dryness – if well maintained they will have a very light coating of oil. Check also that the headliner folds neatly, as here, and does not come away from the frame. A good time also to check the condition of the insulating layer between headliner and outer skin. This is a horsehair mat sandwiched in a cotton bag, neatly edged with vinyl and it should not feel damp between the outer skin and the padding.

Also check the condition of the plastic seals/deflectors (arrowed), which should be firmly riveted to the frame, and not broken, cracked or otherwise damaged.

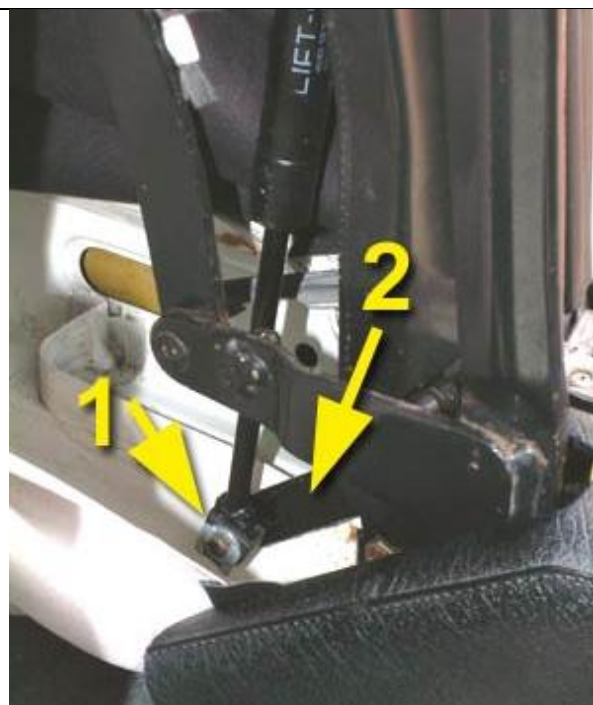
While folding the roof back ease back the headlining at both sides. On manual roof models you will see these gas struts (one each side).

Behind this you should also see adjusting nuts on the ends of the rear tension cable.

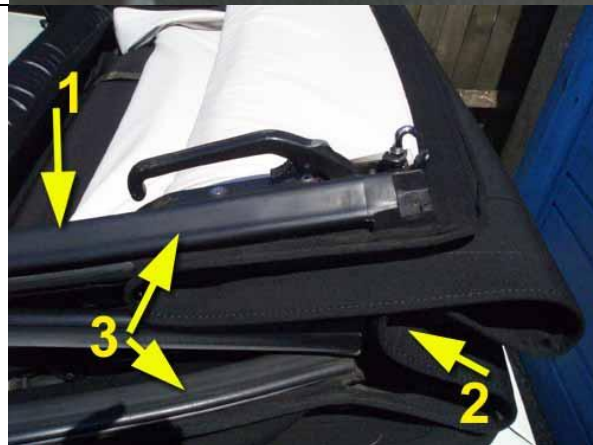
1. Push straight down until the locks click. Should not have to slam it down.
2. Centre fold in correct position.
3. You may just see the slight indentations left by the windows.

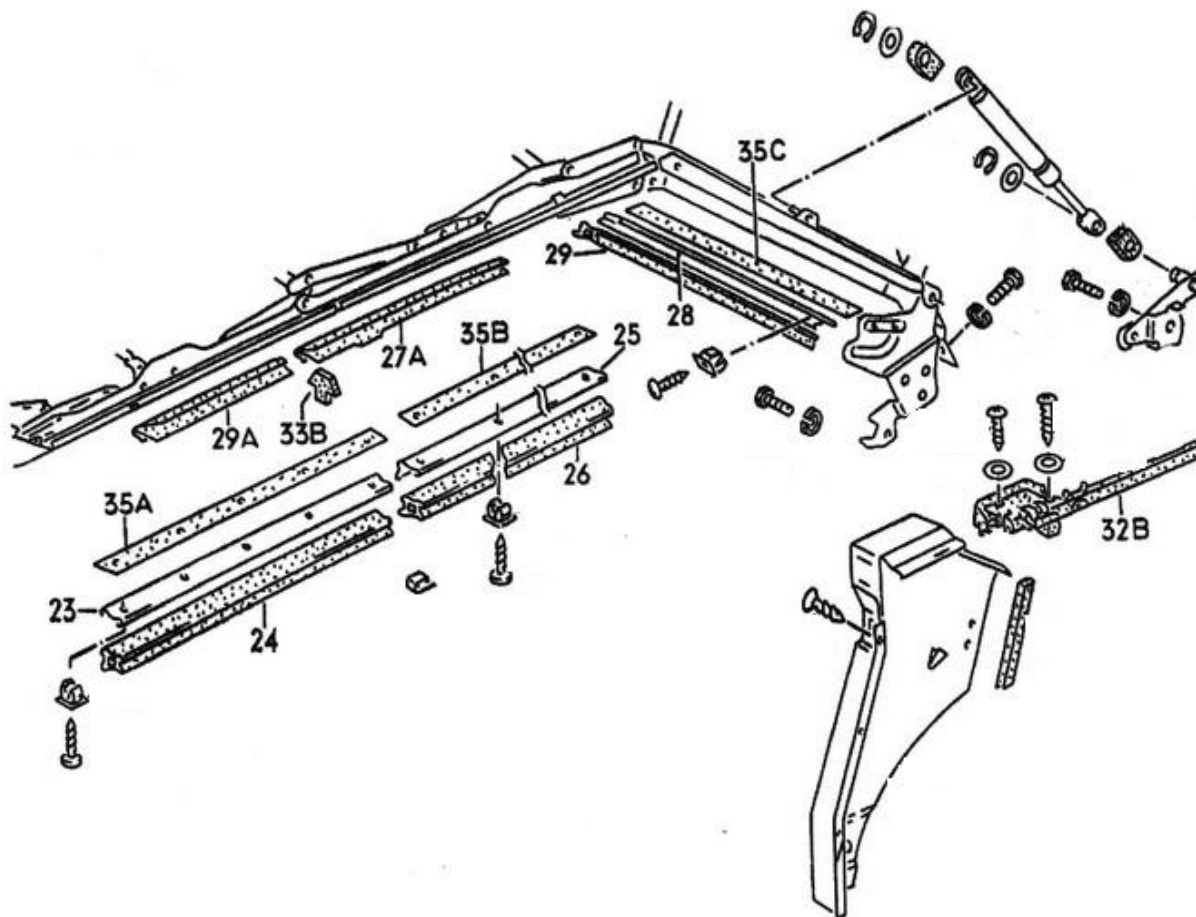
While we are here, have a good look at the seals (refer to the diagram below). They sit in metal frames, with a gasket stuck between them and the main frame. All should be straight and in line with the main frame, with no kinks or damage.

23, 25 & 28 – channels for window seals

35A, 35B & 35C – Gaskets between Frame and window seal channels (NOTE – These are usually the main culprits when investigating leaking roofs, particularly when water seems to drip from the locking handle area)

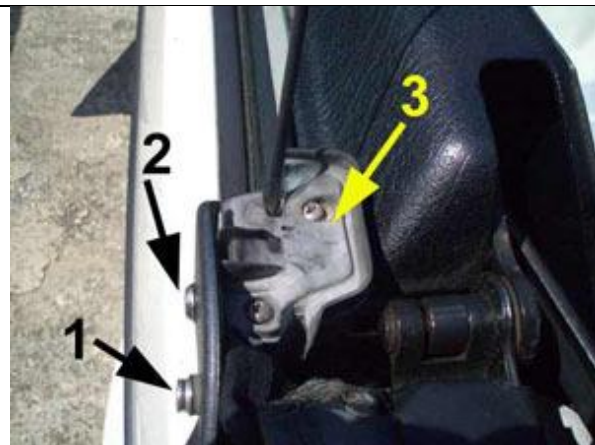
1. Press-stud fixing for the hood cover.
2. Front fixing – the press stud may be in this position – depending on the hood cover.
3. See 32B in diagram above. This seal should be in good condition. It extends rearwards over the panel lip, and fixings 1 and 2 go through it. **If this leaks you will get a boot full of water!**

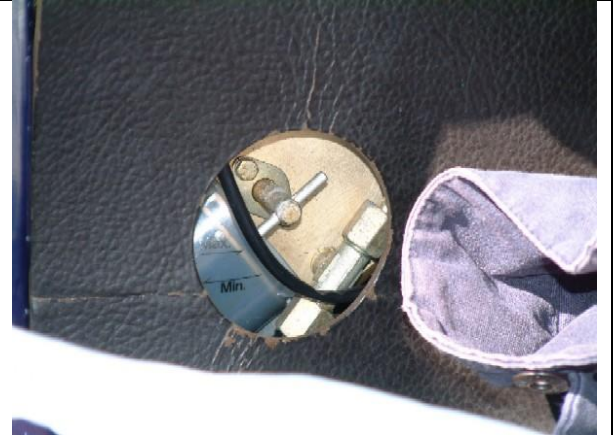
Located behind the nearside trim in the boot is this interlock switch, which allows the roof to be raised manually in the event of electrical / hydraulic failure. The hydraulic system should be checked for correct operation and leaks from the rams, motor, reservoir and all pipes (remove the side panels).

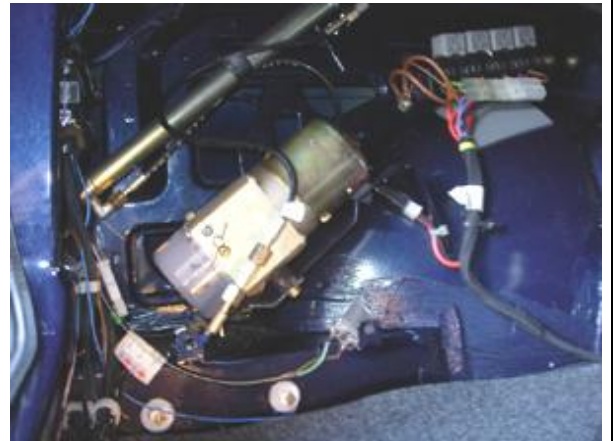
With the side panels off check the hydraulic ram lower mounting plates – do they look original, or have they been added later (look for new paint over the welds), which would indicate that the system is not original. Shown here is the correct layout of the components.

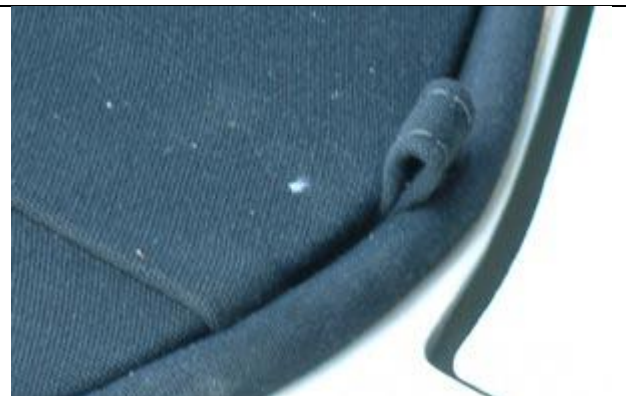
Loop for the 'G' hook (5) above

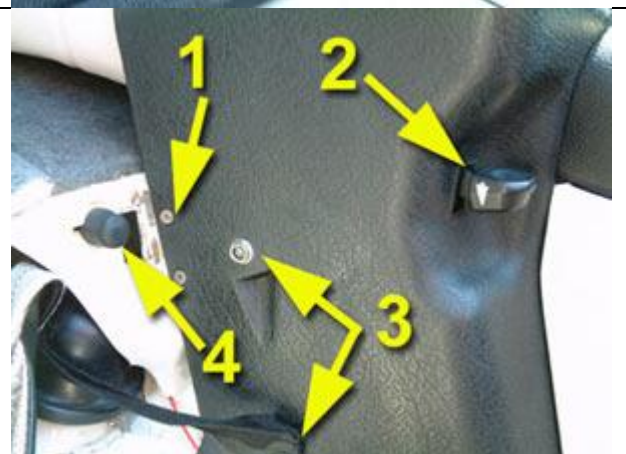
Item 3 (can be 1 or 2 in any position) – locating studs for the elasticated press stud (3 in pic at top of this page)

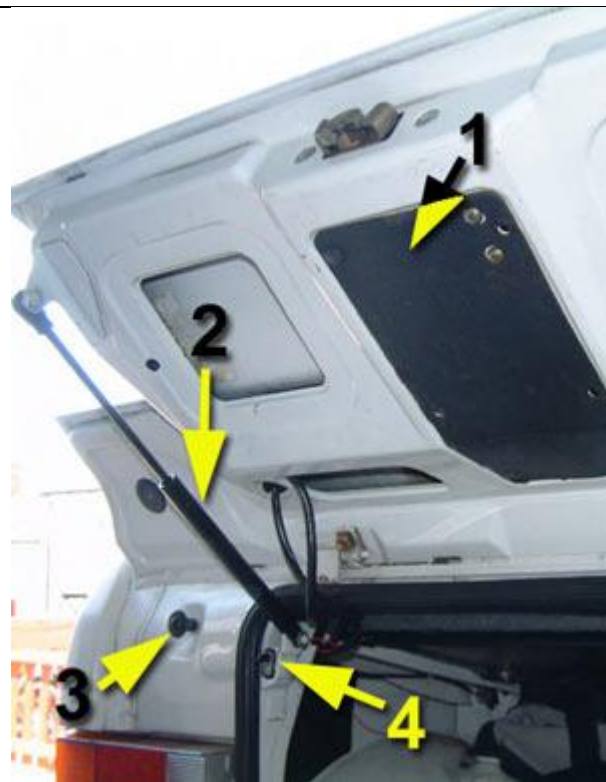
1. Cover for lock mechanism.
2. Boot lid strut. This should assist the boot opening from about halfway (watch your nose!!) and damp it before being fully opened. Check for looseness and any side play.
3. Release knob for rear seat backrest. This should pull out smoothly and click into a locked open position. If you close the boot lid it should be pushed back to the closed position.
4. Boot light switch.

Check all seams, the hinges and the edges of the boot lid for rust or damage.

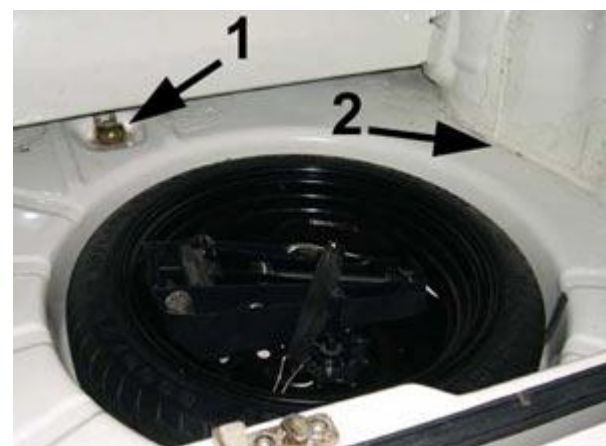
### Spare wheel

1. Rear seat belt centre mounting point.
2. Remove the spare wheel. Check the spare wheel well, and all seams in the boot, for rust.

Any strange holes drilled in the wheel well and the lower rear panel in the boot indicates that a Witter style tow bar has been fitted in the past. Check the nearside rear light cluster wiring for damage where the tow bar electrics have been removed.

Note the original tool kit and scissor jack strapped on the spare wheel.

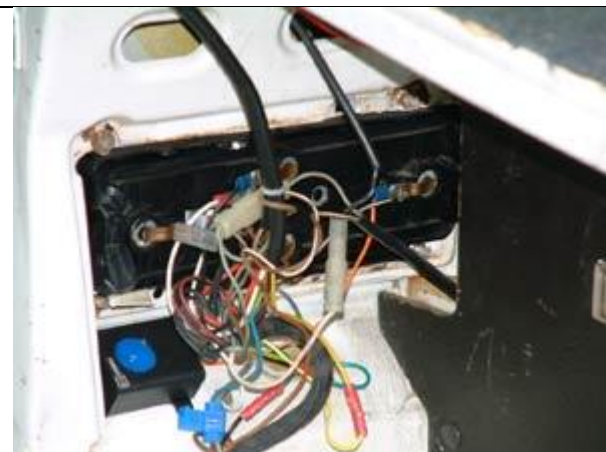
Check for evidence of water ingress and rust behind the rear lights (gasket broken / perished), and that the cover (missing here) for the rear lights is in good condition.

*This wiring is a MESS – and it's mine!!*

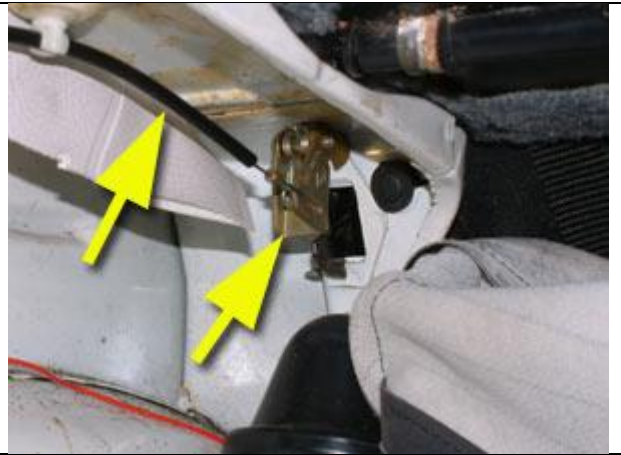
**Rear Seat Backrest**

The rear seat backrest release cable should be clipped to the underside of the parcel shelf support panel. When the release knob is pulled out and locked in the open position the release mechanism should be held clear of the backrest catch. This catch is linked to a similar catch on the other side above the rear suspension strut. These catches are released by pulling a tab from inside the car (see next pic).

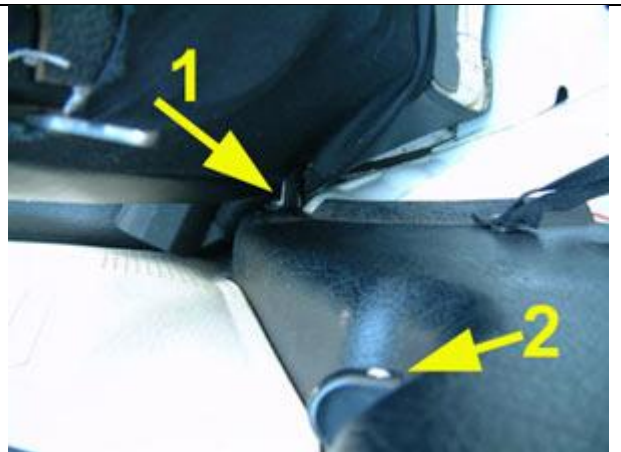
**Seat release tab**

1. The backrest is held on each side by, and pivoted on, a shouldered screw hidden here (looking directly down from just above the hood lock release (2)).

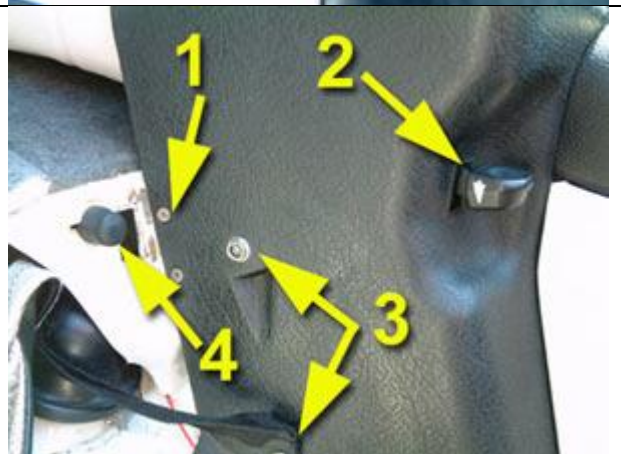
1. Fixing screws for rear trim. Some are hidden behind the side card and under the sides of the rear seat.
2. Roof lock and release knob (NOT on power hoods).
3. Press-studs for attaching the hood cover.
4. Rubber adjustable bump stop – adjusts to hold the rear seat backrest firmly.

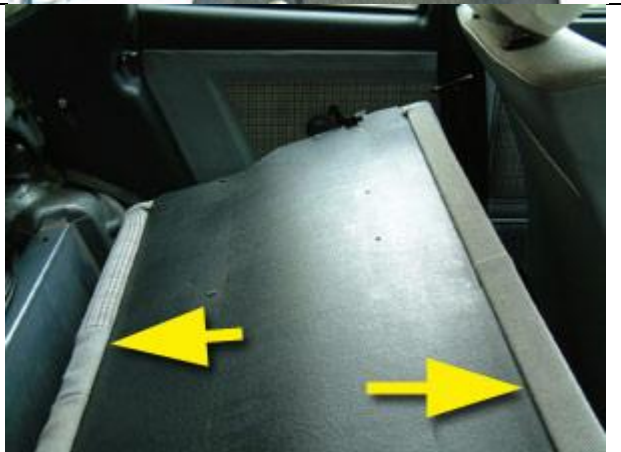
**Rear seat back panel**

The panel should have all plastic pegs fitted, and the top and bottom should be tucked into the rear seat frame as shown.

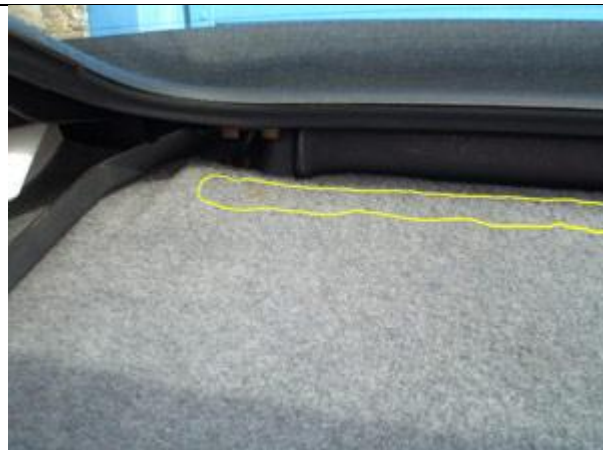
### Parcel shelf

Look for evidence of rust marks (rear window frame leaks).

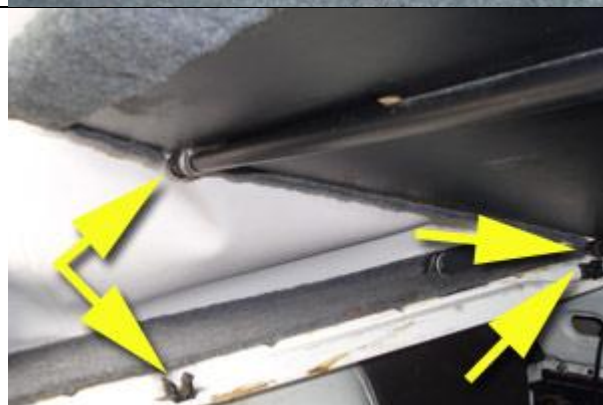
The 2 supports underneath should be straight, and should clip into 4 plastic lugs (one side shown here).

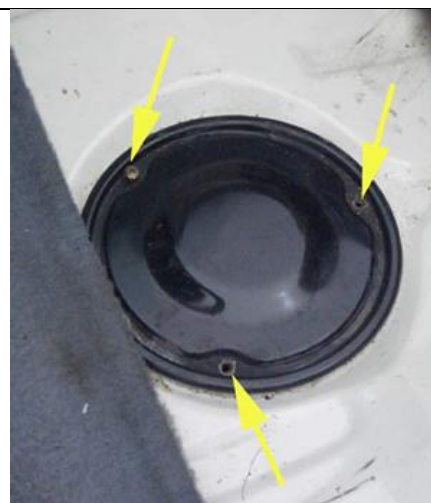
Ask to remove the rear seat base to check that this plate is present – fuel vapour will enter the cabin if the sender unit seal is perished.  
The fixing screws have been removed in this photo.

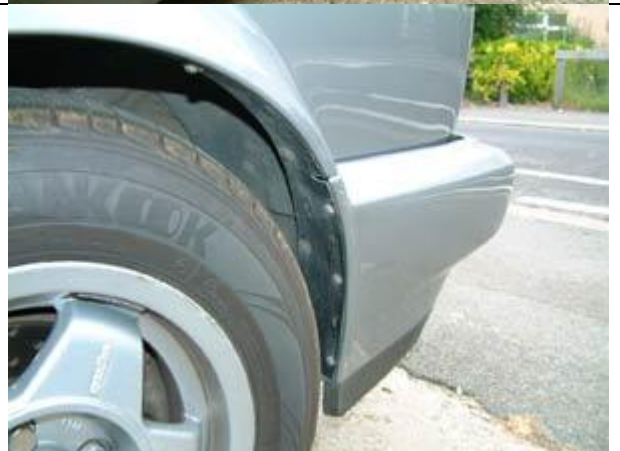
The front wheel arch lining, pop rivets and screw fixings to the bumper and wheel arch trim.

Feel under and behind the arches for any signs of rusty flakes. And check for rivets / screws missing.

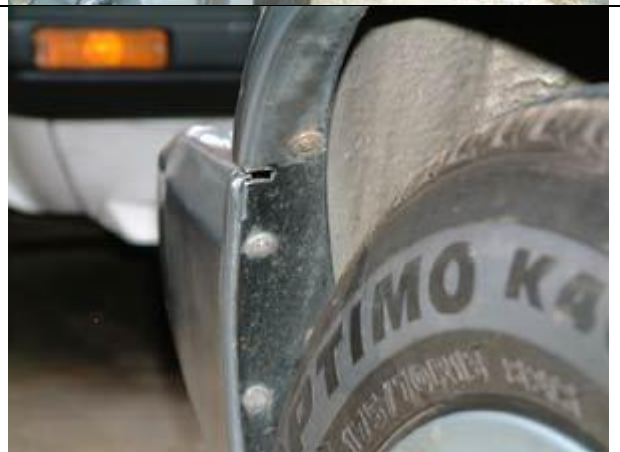
The rear wheel arch lining, pop rivets and screw fixings to the bumper and wheel arch trim.

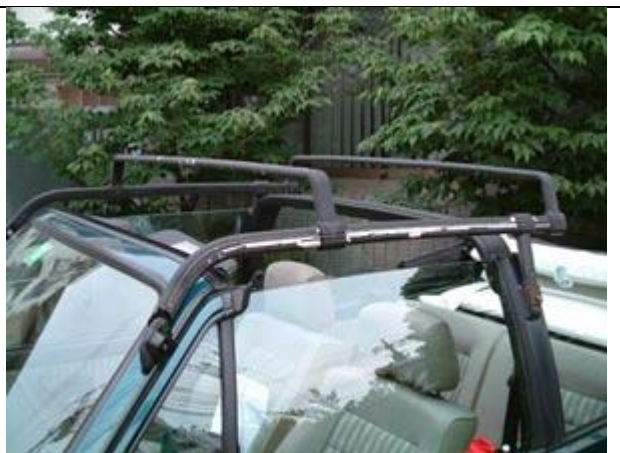
You may see some strange mountings on the 'A' and 'B' (Roll-over bar) pillars. Hopefully the car comes with the roof rack itself, *and if it does it's RARE!*
